Incident Assessment

Incident ID	CIV1907
Location	197 Klochkivska Street, Kharkiv, 61000
Coordinates	50.0163, 36.2128 ¹
Date	28/02/2022
Time	After 06:20 EET and before 13:28 EET (possibly 12:48 EET)

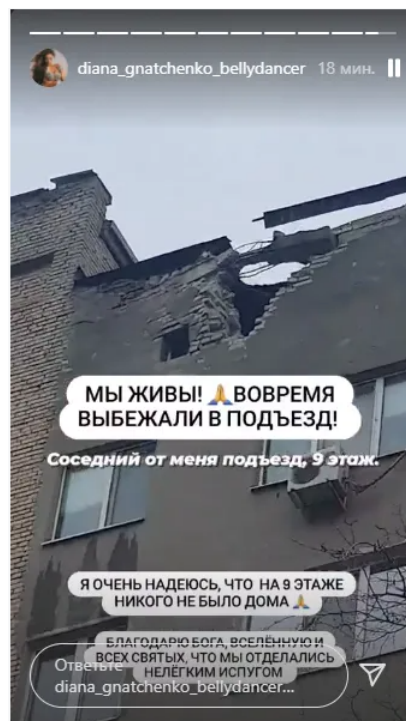
S1I1 depicting the damaged building.

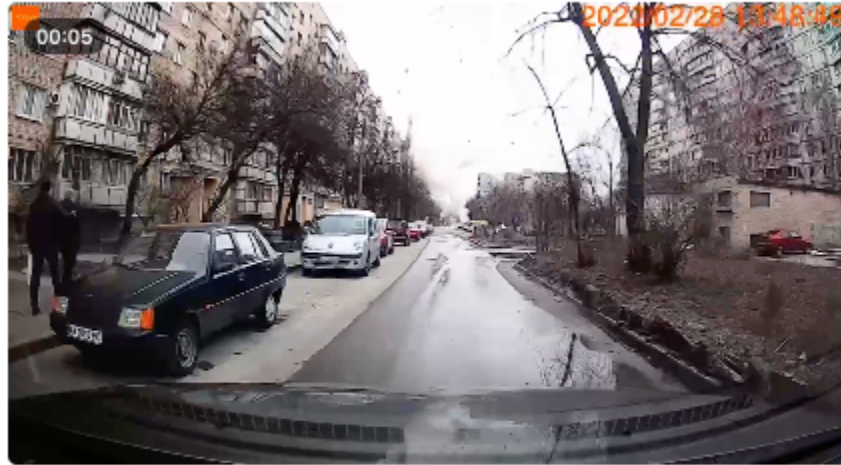
- [Source 2](#)¹⁷: A Telegram video (S2V1) posted on 28/02/2022 at 16:25 EET. The video shows the moment of strike of the top of the high rise apartment building.

A still from S2V1.

However, S2V1, which depicts the moment of the strike, indicates the time and date on a dashcam timestamp which shows 13:48 EET 28/02/2022. This is unlikely to be correct as it is after the time of the first Instagram post. Possibilities to explain this may be that the dashcam shows a later incident that impacted at almost exactly the same location, or that its time is set incorrectly, possibly due to daylight savings time, which is practiced by Ukraine. Of the two possibilities, the former appears unlikely, while the latter is not uncommon. If this is indeed the case, the dashcam indicates that this event took place at 12:48 EET on 28/02/2022.

There is no footage showing the projectile at the moment of impact or an image depicting the embedded munition remnant which hit the building. Therefore, it is not possible to estimate the exact direction of where the munition came from. S2V1, which shows the result of the moment of impact, indicates that the projectile was moving in a generally western direction.

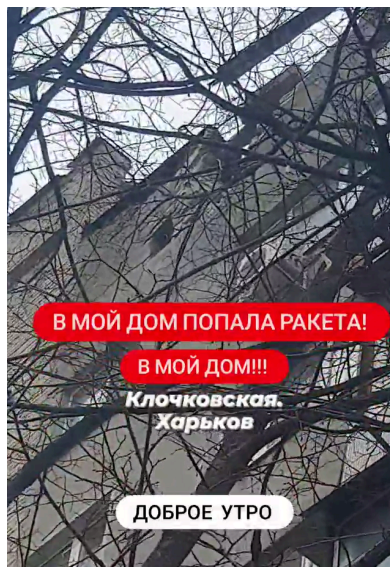
A still from S3V1 taken at 00:04. The text accompanying the video mentions the location and translates to English as follows: “My house was hit by a rocket! My house!!! Klochkovskaya, Kharkov. Good morning.”

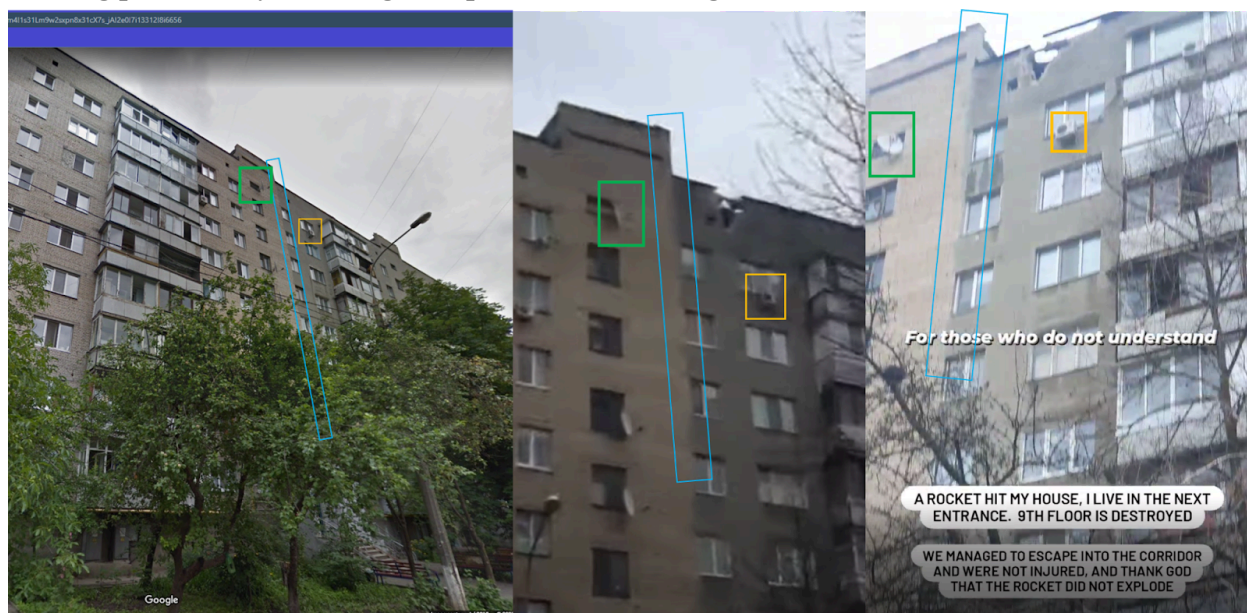
Left: [Google Maps street view](#)²² of the building indicating a join between two walls - one colored gray and one with beige bricks (marked with blue rectangle), as well as a satellite dish on the top left window (marked with green rectangle) and an air conditioner on the right top window (marked with orange rectangle). Centre: A still from S4V1 at 00:29 containing the same objects. Right: A still from S3V3 at 00:01 containing the same objects.

Images and videos of the building on 197 Klochkivska Street correspond to the image of the building provided by the Google maps Street View image.

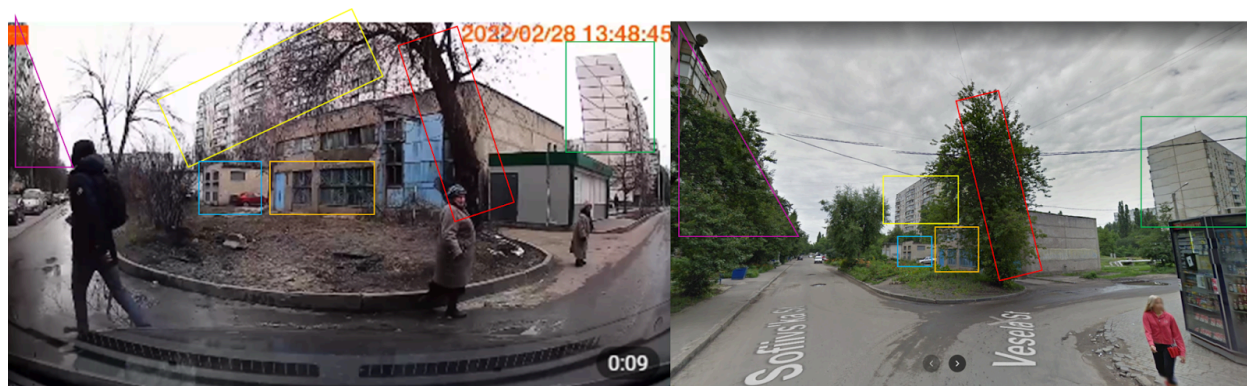
Left: A still from S2V1 at 00:09 depicting an apartment building on the right (marked with green rectangle), followed by a tree (red rectangle) and a lower building with blue door and windows (orange rectangle), followed by another lower building with gray doors and windows (blue rectangle), and a high-rise apartment building in the background (yellow rectangle), as well as another high rise apartment building across the street (purple triangle); Right: [Google Maps street view](#)²³ containing the same objects.

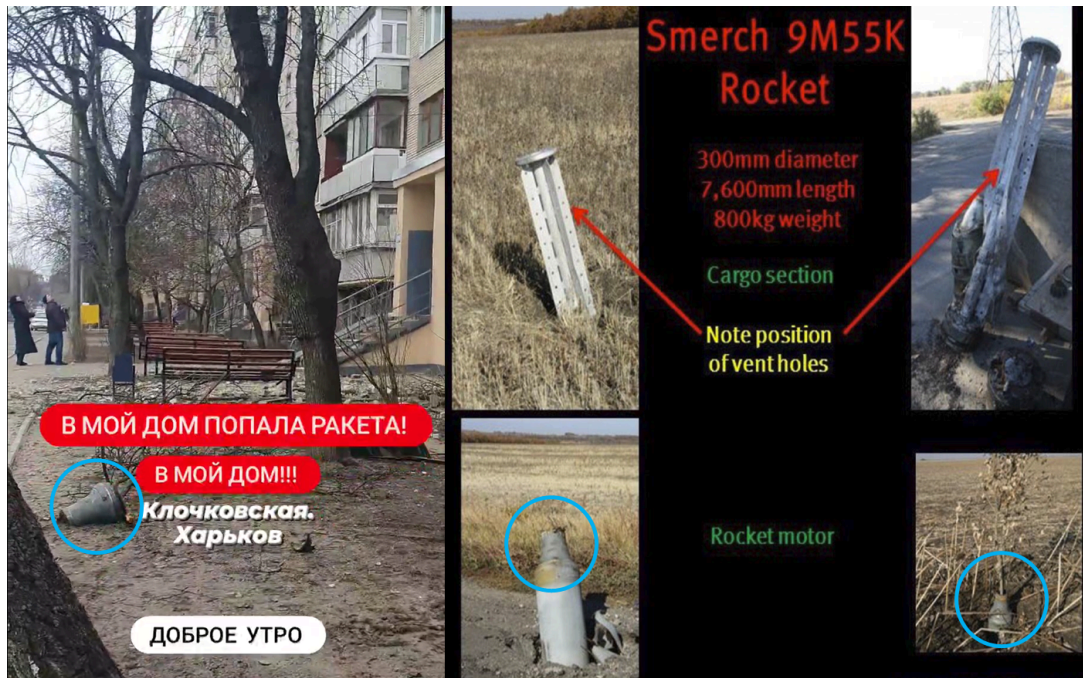
S3V1 depicts what appears to be the cone of a rocket motor at the base of the building which was impacted. The conical end part of the rocket motor depicted in S3V1 matches that of a 9M55K rocket motor.

Left: A still from S3V1 taken at 00:00 depicting a conical object which appears to match those seen on 9M55K rockets. Right: [A reference card](#)²⁸ from the official Twitter page of the Human Rights Watch Associate Arms Director.

An attack on 197 Klochkivska Street took place after 06:20 EET and before 13:28 EET, and possibly at 12:48 EET. No information about victims of this particular Incident seems to be available. It appears that the conical part of the rocket motor is from a 9M55K rocket, indicating that this was from a cluster munition attack. No military structures, installations or other assets were identified within 1 km radius of the location of the Incident, however the Ivan Kozhedub National Air Force University was identified just outside this radius.

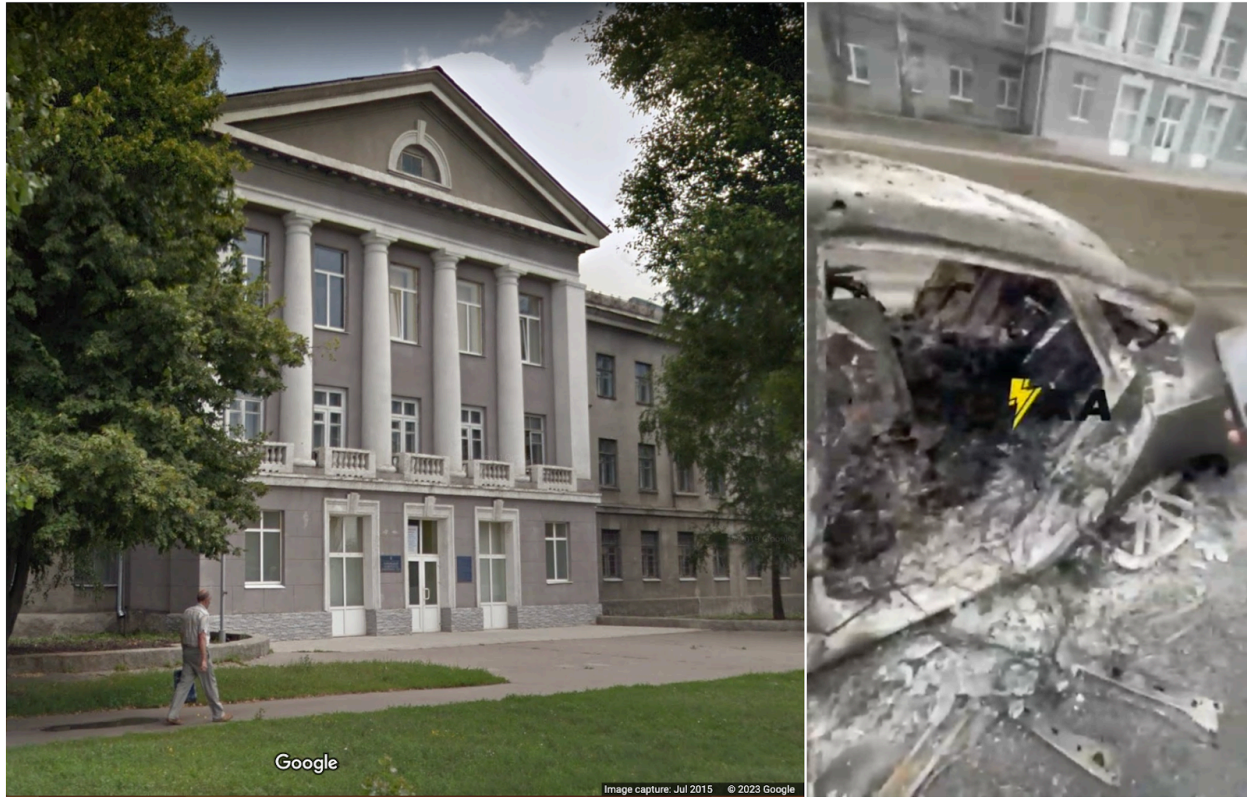
Left: Building marked as the “[Faculty of Information and Technical Systems](#)”³⁴ as seen on Google Street View. Right: burnt-out car as seen in CIV0119 with what appears to be a matching building in the background.

The vehicle is completely burnt-out and so any damage which could have been caused by fragmentation is not visible. No impact or fragmentation marks are visible on either the tarmac or grass. This incident could be geolocated to the south-eastern corner of the [National Air Force University](#)³³, approximately 1 km away from the points of impact.
