# Incident Assessment

Incident ID	CIV0097
Location	Horizon, Obriy District, Kharkiv, Kharkiv Oblast
Coordinates	<a href="https://maps.app.goo.gl/yBV7difXhUrgSXE4A">49.9277, 36.4332</a> <sup>1</sup>
Date	28/02/2022
Time	Likely at around 10:42 EET

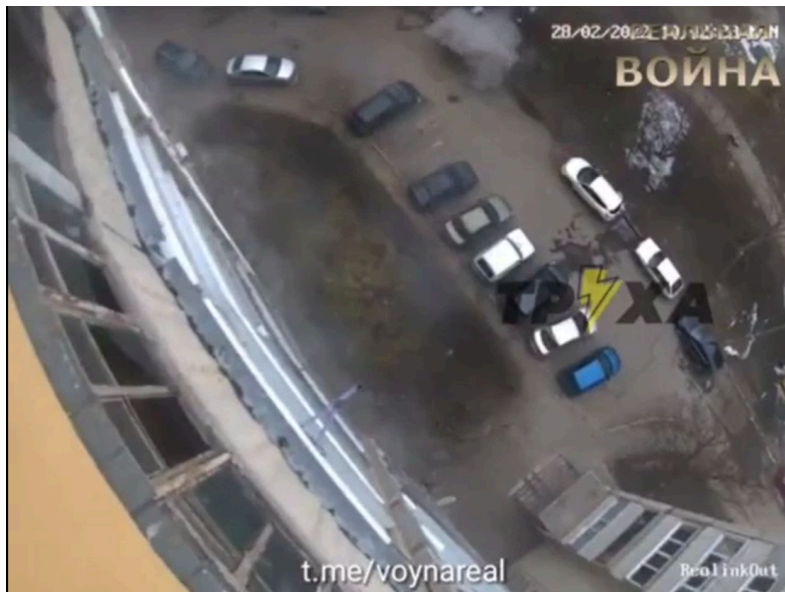
The investigation started with [SIV](#)<sup>13</sup>. This CCTV video showed several explosions taking place in a parking lot next to an apartment building. Three individuals could be seen running, one of whom fell to the ground. This video had text overlaid on top of it.

*A screengrab of [SIV](#)<sup>14</sup> depicting the video overlaid with text in the top-right corner, and the name of the Telegram channel bottom-center.*

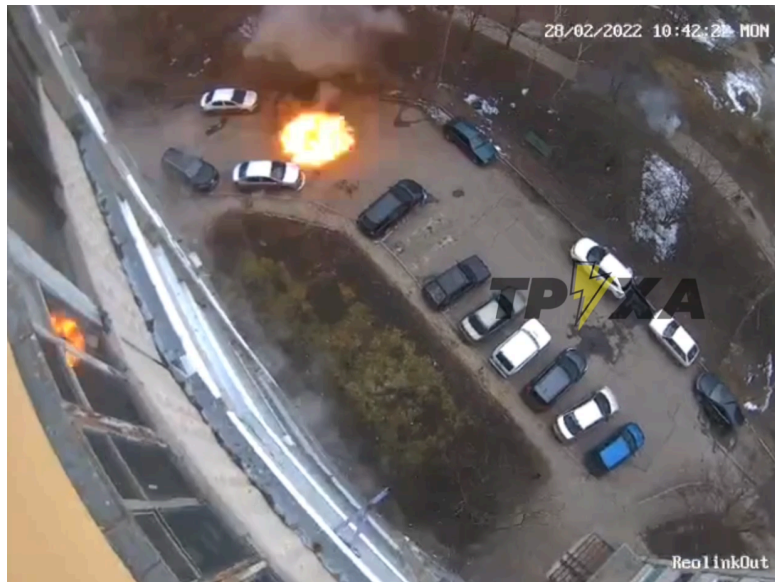
*A screengrab of [S2V1](#)<sup>17</sup>, showing detonations, a date and time stamp, as well as two of the three individuals in the top right corner.*

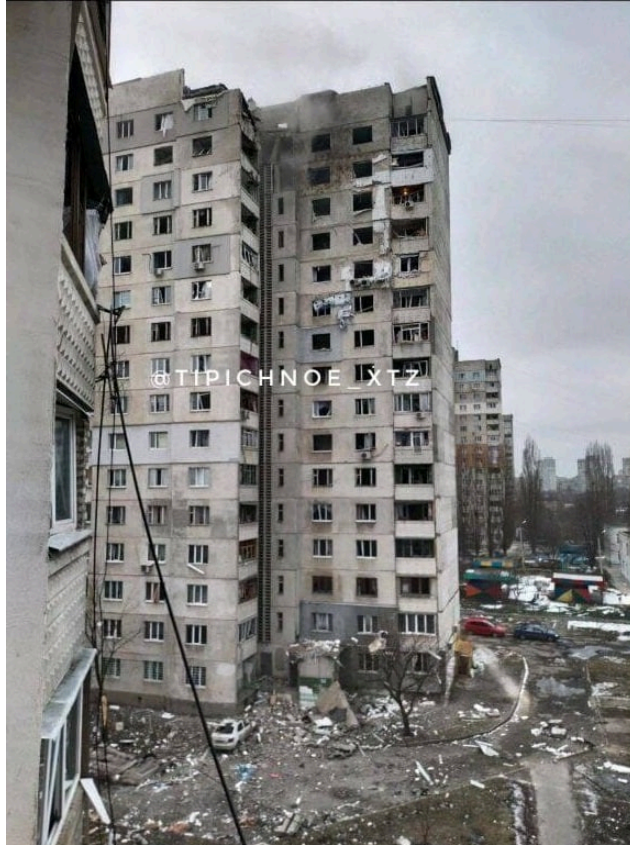
*[S4I1](#)<sup>23</sup> was posted in the same context and around the same time as previous images related to S2V1.*

The type and level of damage seen in S1V1, S2V1, S3I1, S7 and S8 is indicative of a cluster munition attack, however the damage seen in S4I1, S4I2, S6V1 and S5I1 appears to be of a higher order and as such was likely caused by a different weapon system. This indicates that this location was likely hit by two different weapon systems within several days.

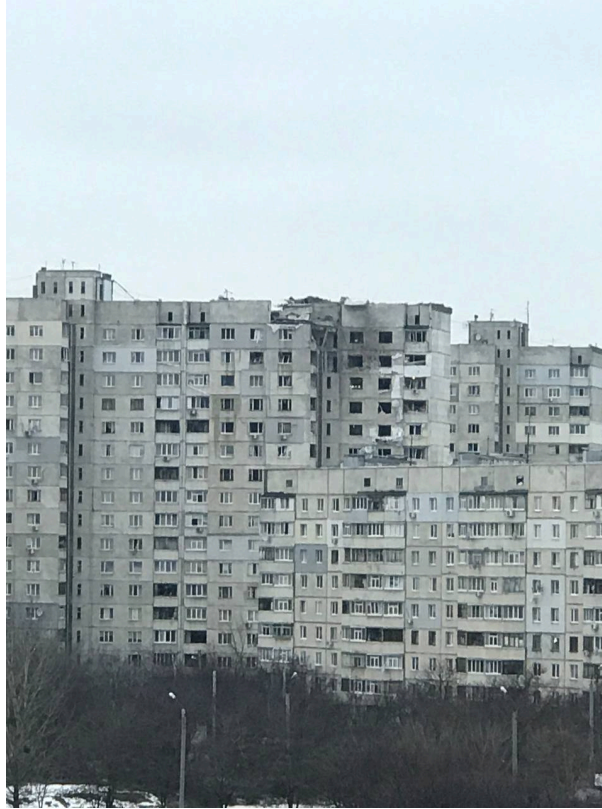
[S5I1](#)<sup>24</sup> depicts the same building as [S4I1](#), from a different angle.

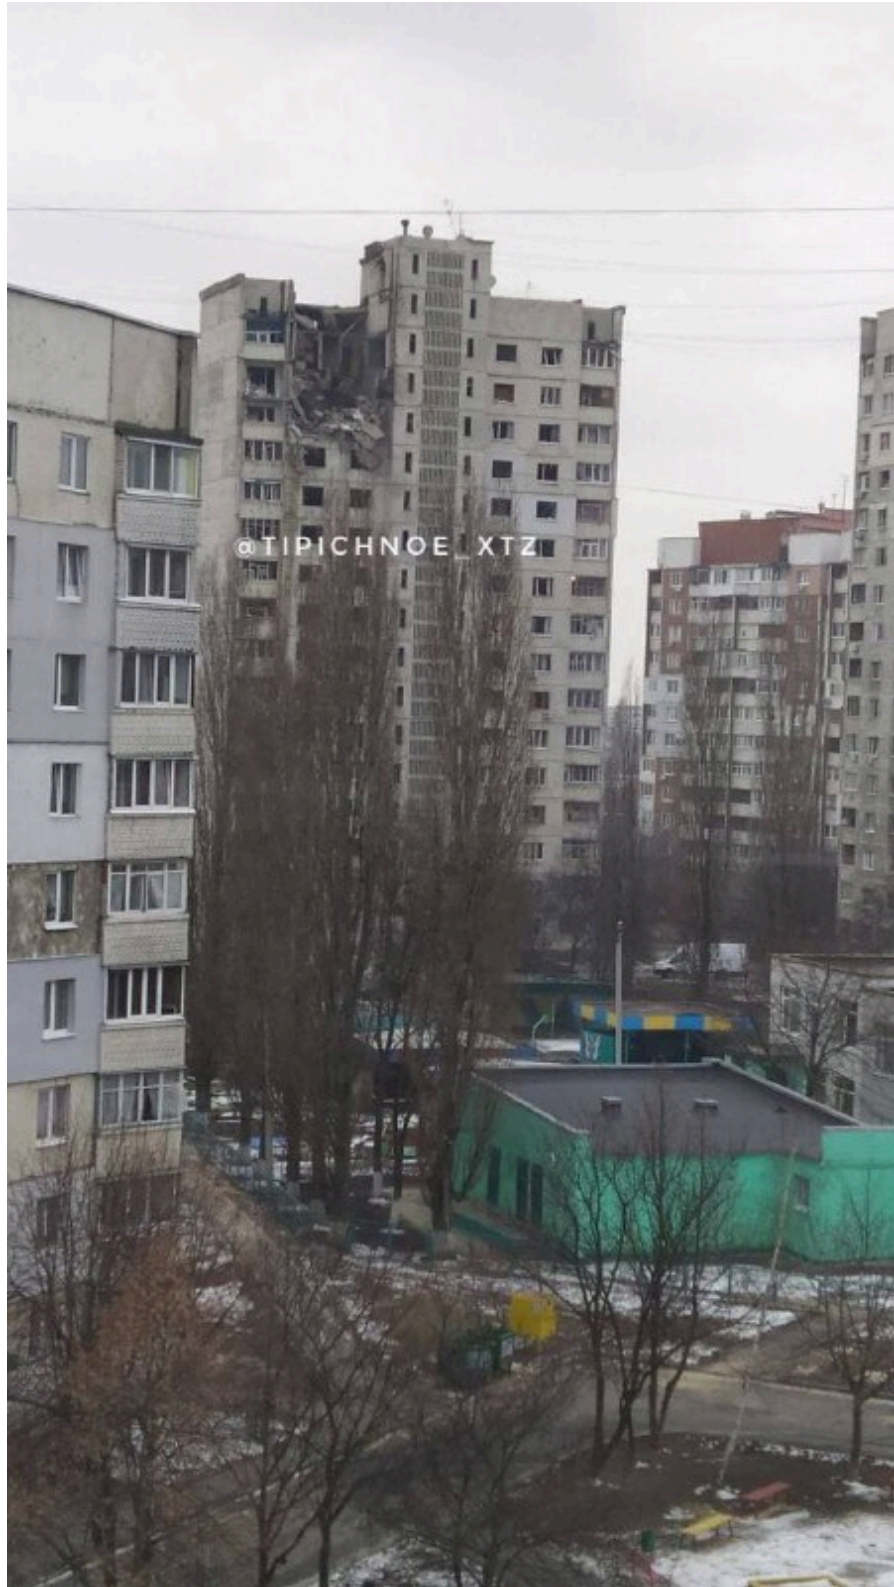
[S4I2](#)<sup>27</sup> was also posted in the same context and around the same time as previous images related to S2V1.

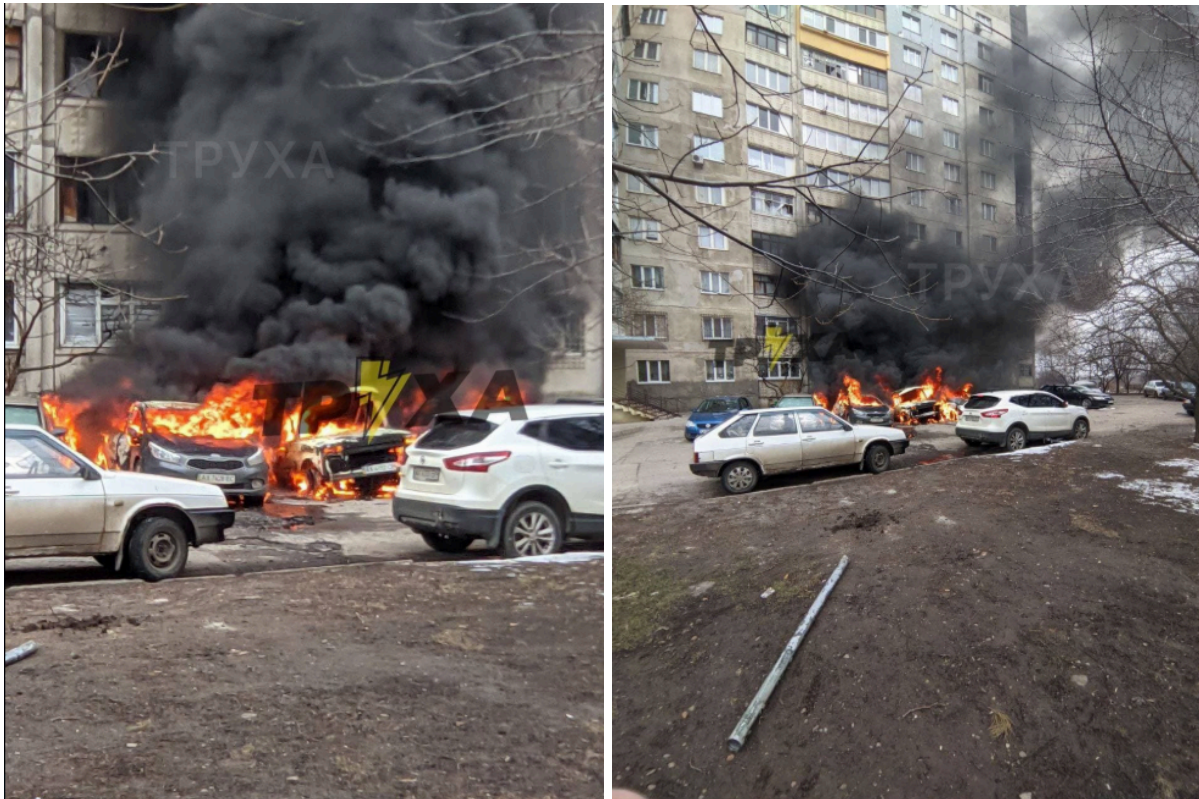
[S7I1](#)<sup>29</sup> and [S7I2](#)<sup>30</sup> depicts the aftermath of the explosions seen in S1V1, with the same cars in the same places.

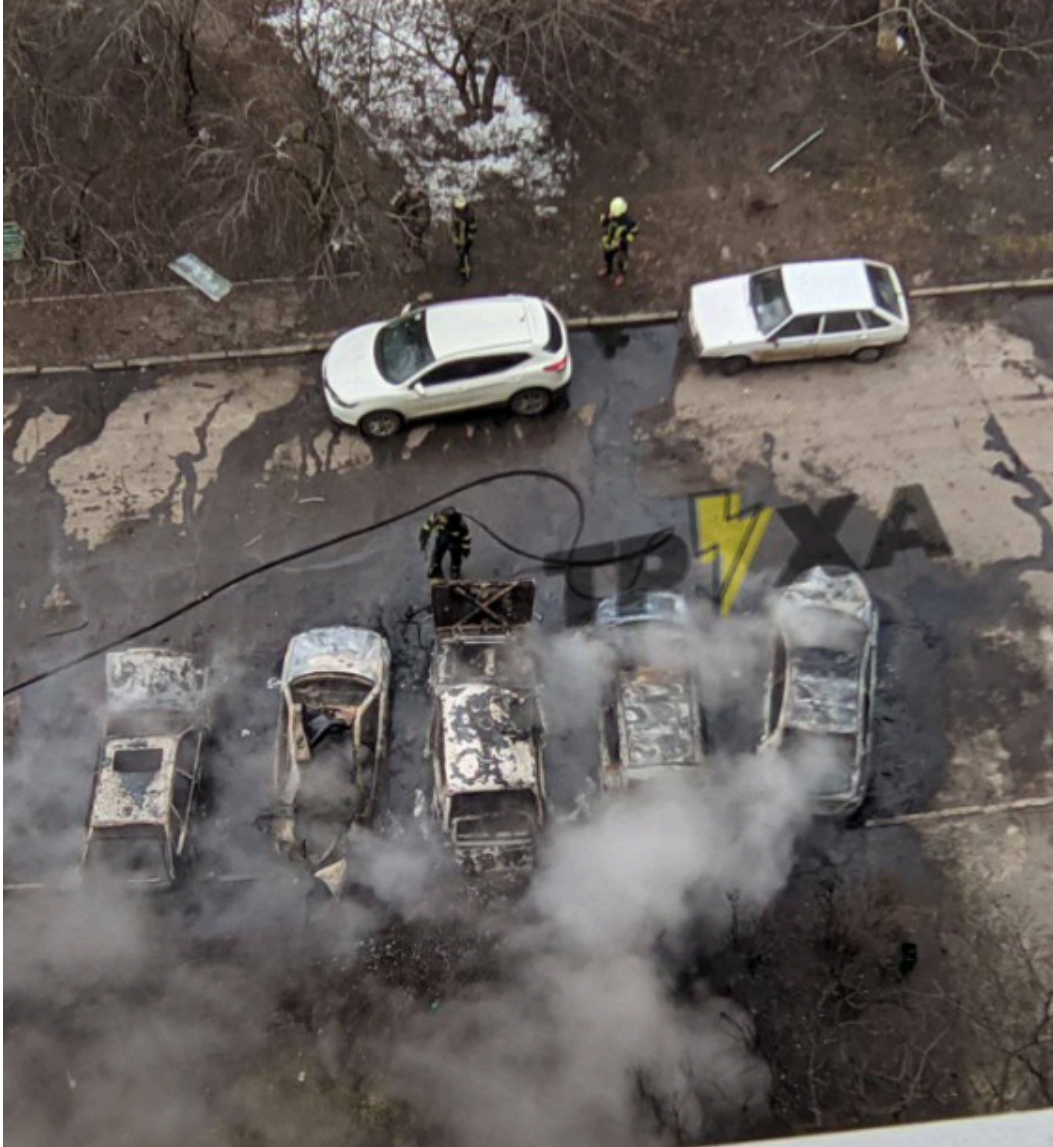
*[S8I1](#)<sup>32</sup> depicts the aftermath of the explosions seen in S1V1 with burnt cars from above.*

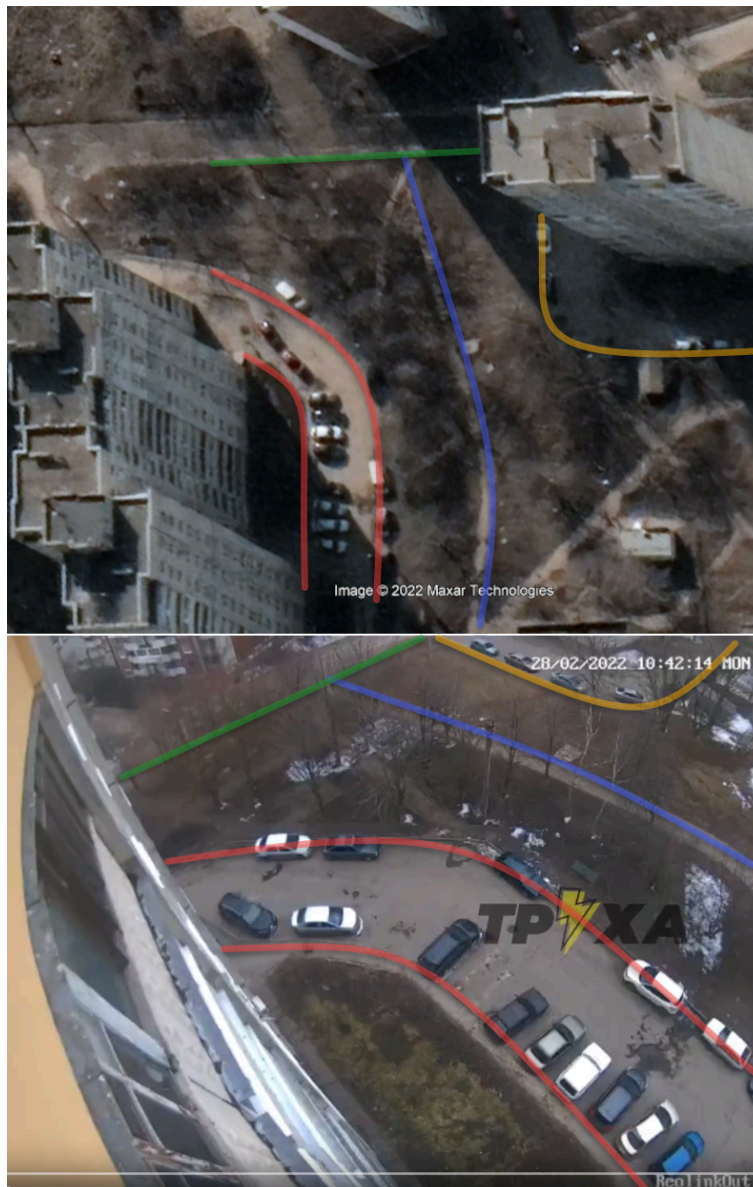
The other sources, S1V1 S2V1, S3I1, S7I1, S7I2, and S8I1, can be geolocated to Velyka Kil'tseva St, 128 Kharkiv.

*Top: A Google Earth image of Velyka Kil'tseva St, 128 Kharkiv (Credit: Google Earth/Maxar Technologies). Bottom: A still from [S2V1](https://t.me/truexanewsua/26191)<sup>33</sup>. The angle of the video and matching elements are highlighted.*

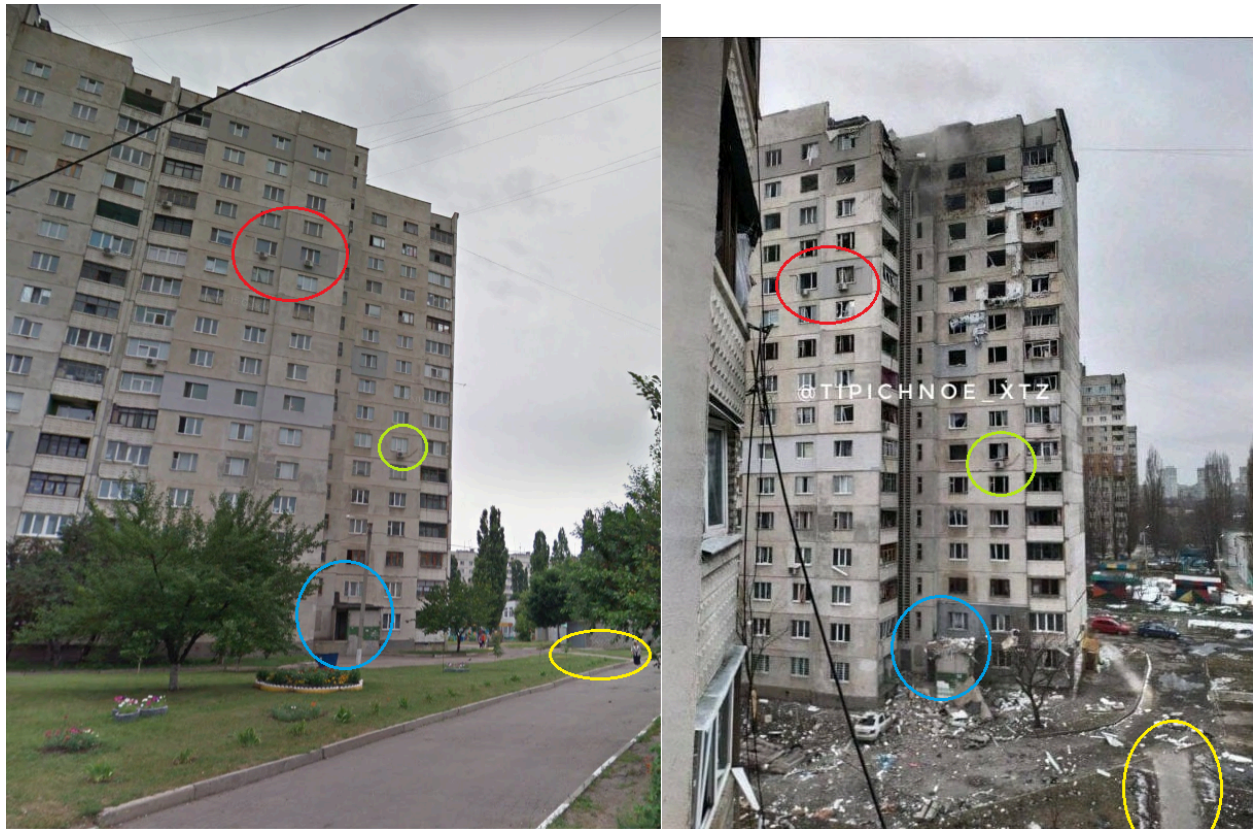
[S4I1](#)<sup>34</sup> and [S5I1](#)<sup>35</sup> can be geolocated to Velyka Kil'tseva St, 132, which is roughly 100 meters to the east of Velyka Kil'tseva St, 128. This is consistent with the mentioning of 'Horizon' in [S1V1](#)'s<sup>36</sup> description on Telegram.

*Left: A Google Street View image of Velyka Kil'tseva St, 132 Kharkiv (Credit: Google Maps). Right: [S4I1](#)<sup>37</sup>, showing the damaged building. Matching elements have been highlighted.*

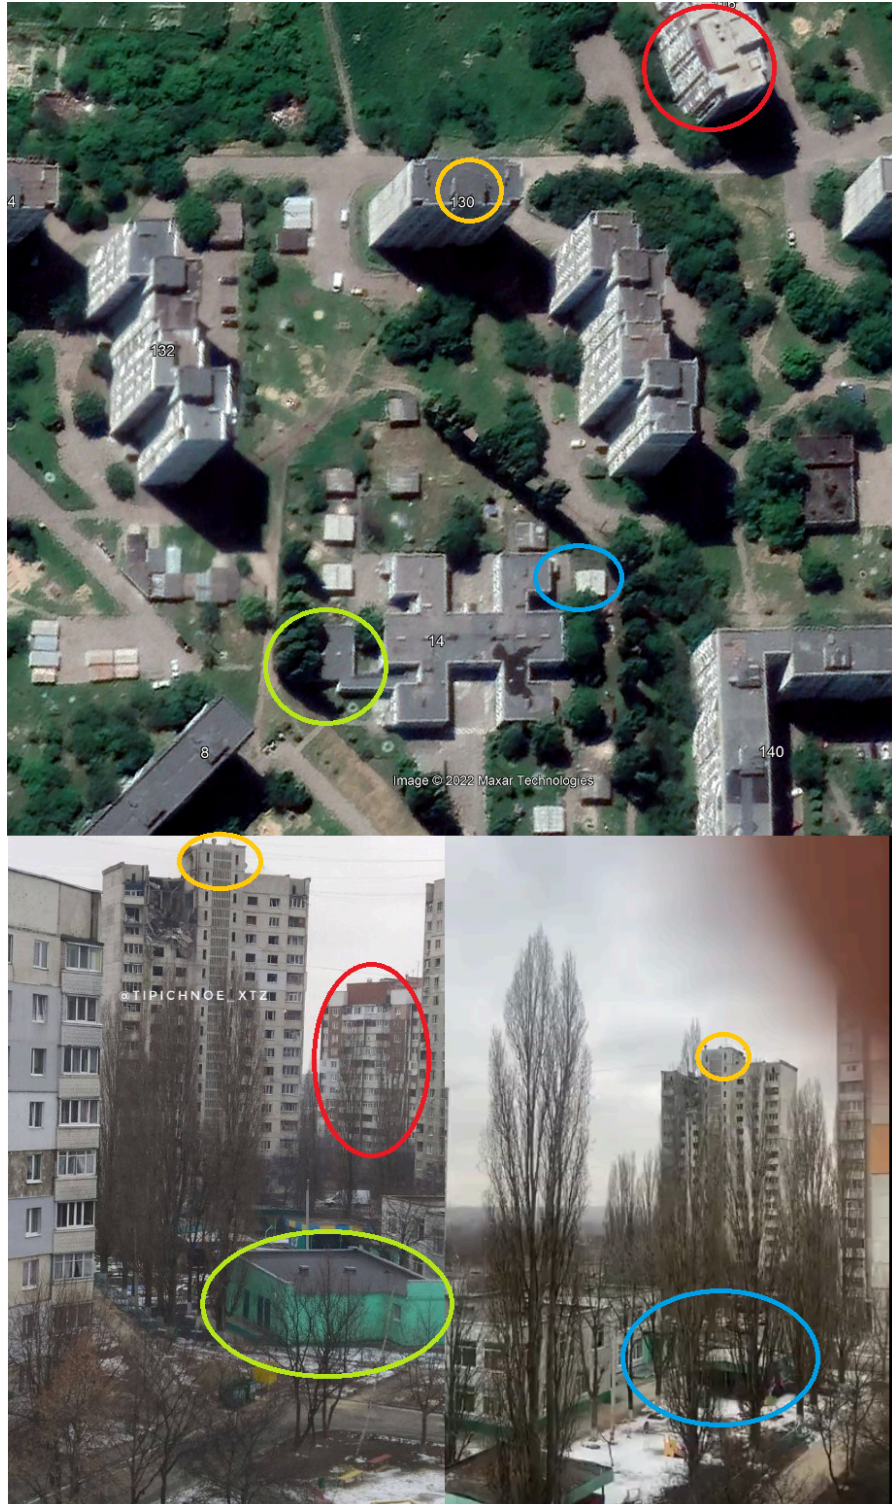
Finally, [S4I2](#)<sup>38</sup> and [S6V1](#)<sup>39</sup> can be geolocated to a building situated between #128 and #132 at Velyka Kil'tseva St, 130, approximately 90 meters away from the scene of [S1V1](#)<sup>40</sup> and [S2V1](#)<sup>41</sup>.

Top: A Google Earth view of Velyka Kil'tseva St, 130, Kharkiv (Credit: Google Earth/Maxar Technologies). Bottom right: [S4I2](https://t.me/s4l2)<sup>42</sup> showing the damaged building. Bottom left: [S6V1](https://t.me/s6v1)<sup>43</sup> shows the same building from a different angle. Key matching elements have been highlighted.

The recorded explosions and resulting damage that were shared on 28/02/2022 are located in close proximity to each other, all within a distance of approximately 180 meters. Buildings 128, 130, and 132 on Velyka Kil'tseva St, Horizon microdistrict of Obriy, Kharkiv were all hit on the same day.

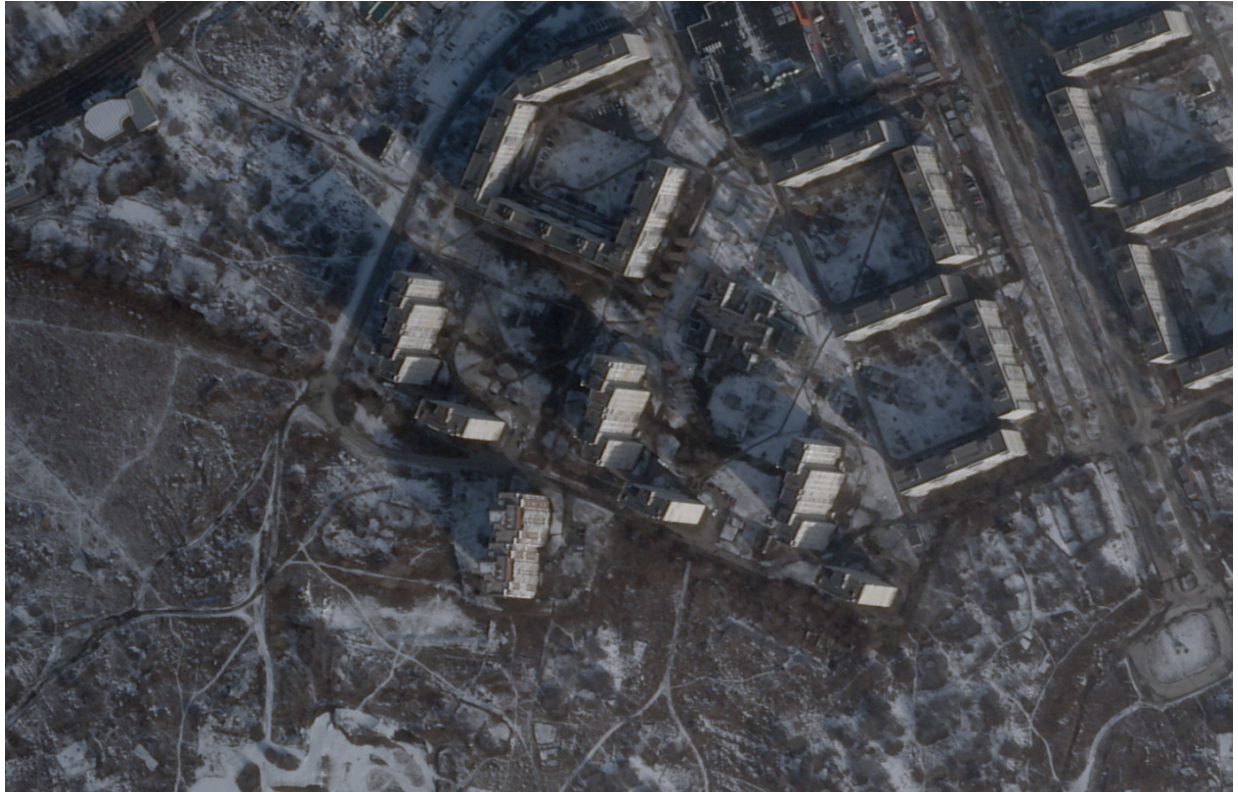
No military objects were identified through open source research. Satellite imagery of this area taken on the day before, 27/02/2022 by Planet Labs, does not appear to show any military structures, installations or other assets.

*Planet Labs SkySat imagery taken on 27/02/2022 (Credit: Planet Labs).*
