Incident Assessment

Incident ID	CIV0091
Location	50 Balakireva Street, Kharkiv, Kharkiv Oblast
Coordinates	50.0325, 36.2386 ¹
Date	28 /02/ 2022
Time	Likely between 06:28 and 10:35 EET, but before 11:14am EET

In the early hours of 28/02/2022, a 9M55K rocket motor impacted into the 11th floor of a building at 50 Balakireva Street in Kharkiv, falling down into the 10th floor below. The first video of the incident was likely filmed sometime between 06:28 and 10:35 EET, with other reports of the event beginning from 11:14 EET.

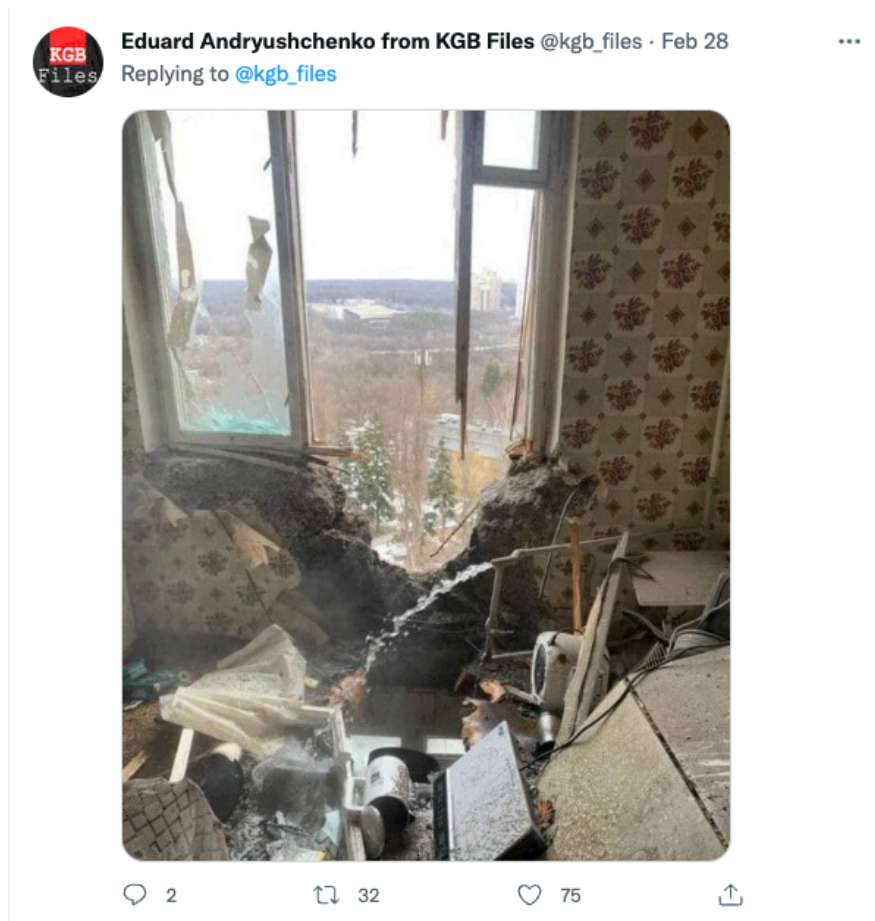
S1I1

- [Source 1](#)¹¹: A Twitter post containing a video (S1V1) and an image (S1I1) posted on 28/02/2022 at 15:11 EET, depicting what appears to be a rocket motor in a residential building.

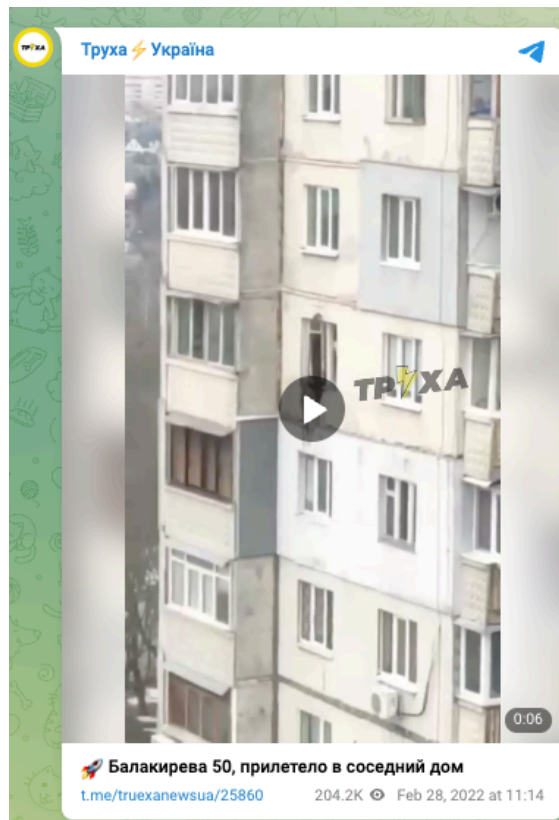
- [Source 2](#)¹²: A Telegram post containing a video (s2V1) posted on 28/02/2022 at 11:14 EET. The video shows an outside view of the building, with what appears to be the same hole as seen in S1I1. In the background of the video voices can be heard saying that the munition impacted the 11th floor.

A still from S2V1 depicting the exterior of the building.

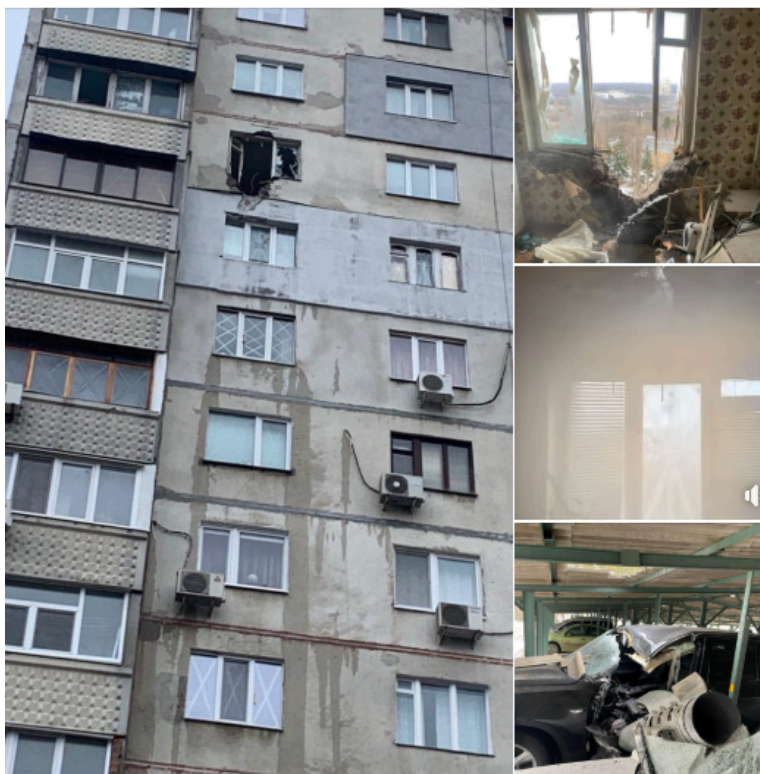
- [Source 3](#)¹³: A Facebook post containing multiple photos (including the same video and photo as contained by Source 1), posted on 28/02/2022 at 14:34 EET by the then Prosecutor General Irina Venediktova. One photo shows the outside of the building with a large hole visible, another, likely unrelated photo shows what appears to be a rocket motor in a garage.

Source 3 containing: an image of the exterior of the impacted building (Left, S3I1); an image of the impact taken from inside (Top right, S3I2 - the same as S1I1); a video of the impact as seen from inside (Middle right, S3V1 - the same as S1V1); and a photo depicting remnants of a munition in a garage, likely unrelated to this particular incident (Bottom right, S3I3).

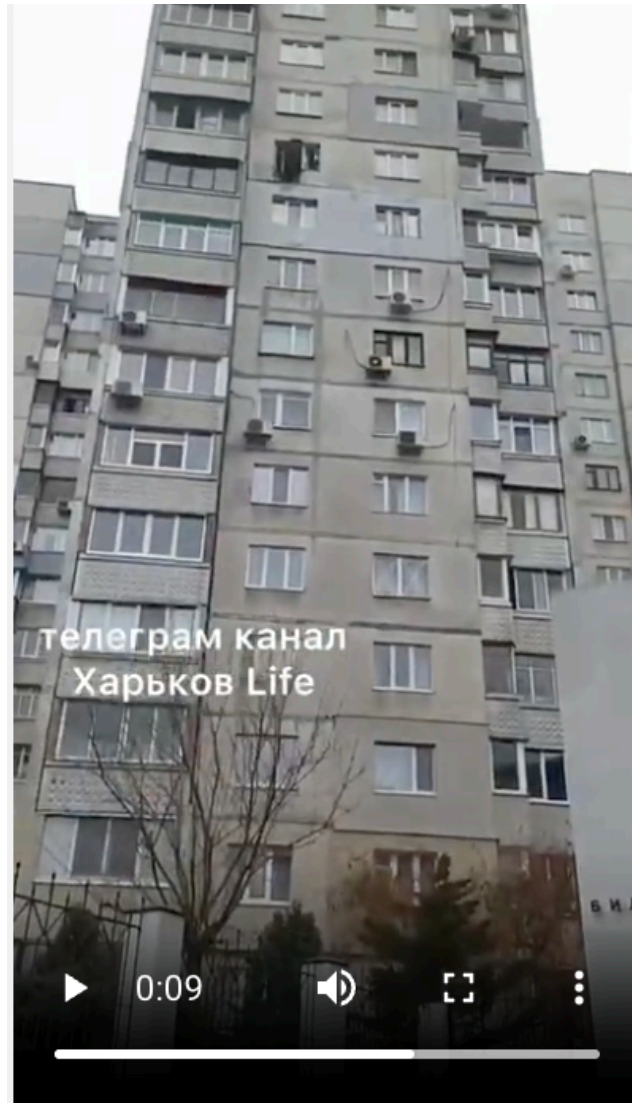
- [Source 4](#)¹⁴: A YouTube Video (S4V1) posted on 28/02/2022 at 11:57 EET, showing rubble on the street before panning up to the building showing the same hole as visible in S2V1 and S3I1.

A still from S4V1 taken at 00:09.

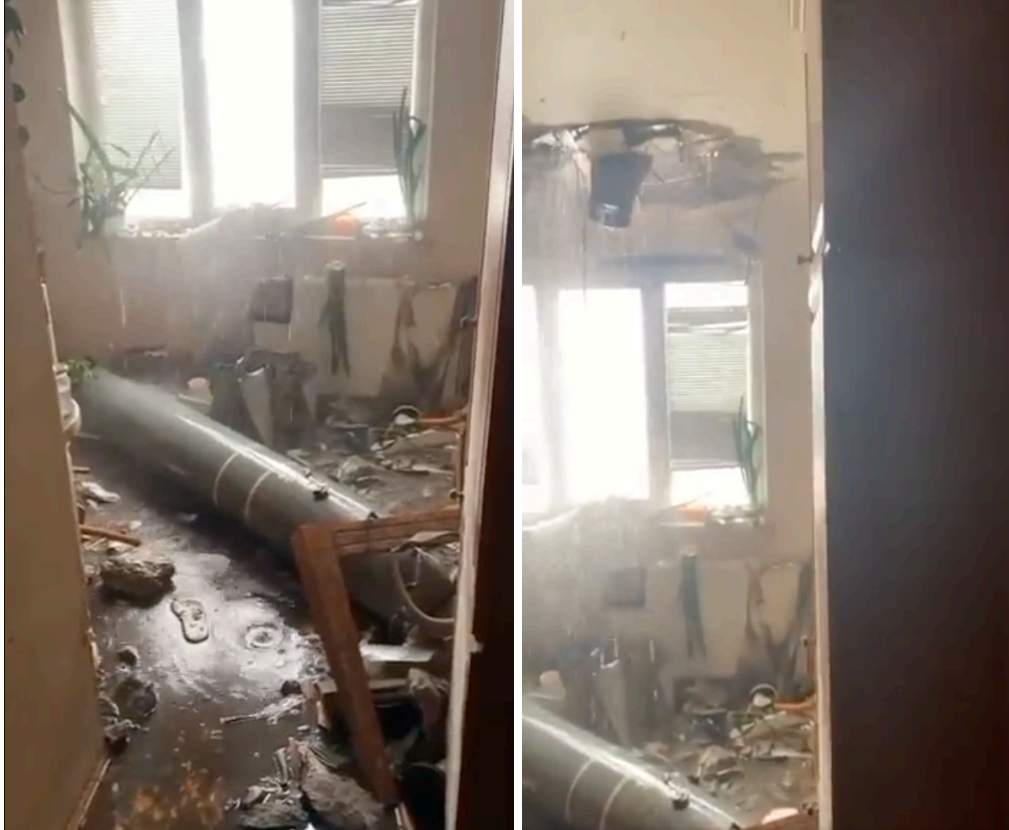
S1V1 shows a rocket motor in a room, having dropped in from the floor above, with a large hole in the ceiling above. S1I1 shows the hole created by the motor entering the building.

Left: A still from S1V1 taken at 00:01. Right: A still from S1V1 taken at 00:04.

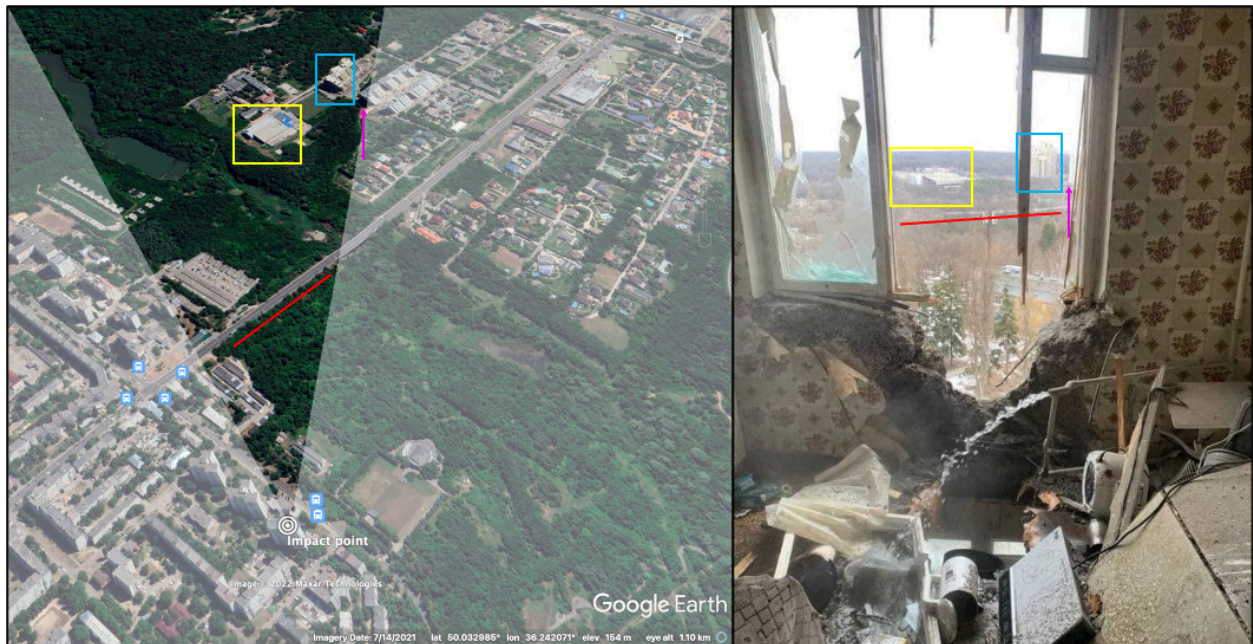
Left: Satellite imagery from 14/07/2021 showing the viewpoint from the apartment (Credit: Google/Maxar Technologies). Right: S1I1. Note that the matching features are highlighted by various colours.

Through the scenery visible in S1I1 through the hole in the wall, the Investigator identified a white roof with raised edges, an apartment building to its right, greenery in between the building and what was visible in the background, and a road dividing the greenery. Searching through satellite imagery on Google Earth Pro in the vicinity of the given coordinates, the Kharkiv Christian Church was identified as the building visible, with a large flat white structure, with raised edges. This was also next to tall apartment buildings, also visible in S1I1 and aligned with a large road: Derevianka Street.

The buildings present to the south-east of the Kharkiv Christian Church are consistent with what is visible in S1I1. The Google Street View images of the church and of the apartment building complex “Белый Слон” also confirm this. These buildings are all high rise buildings as seen in the photo. Note: there only appears to be one building in the photo but this is explained by the viewpoint of the camera – the longest edge of the Kharkiv Christian Church aligns with the

apartment complex, hiding it from view. The road, Derevianka Street, also appears to align with the road visible in S1I1.

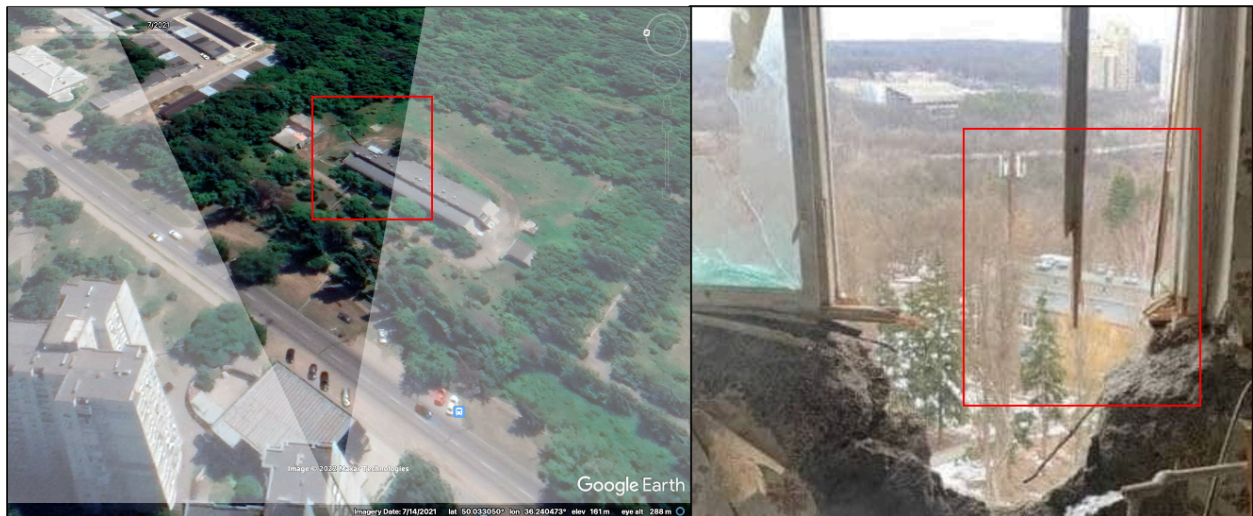
Additionally, in S1I1 some form of a mast can be seen immediately next to a building. This matches exactly with the identified location.

Left: Satellite imagery from 14/07/2021 showing the viewpoint from the apartment (Credit: Google/Maxar Technologies). Right: S1I1. Note the mast and building are highlighted in red.

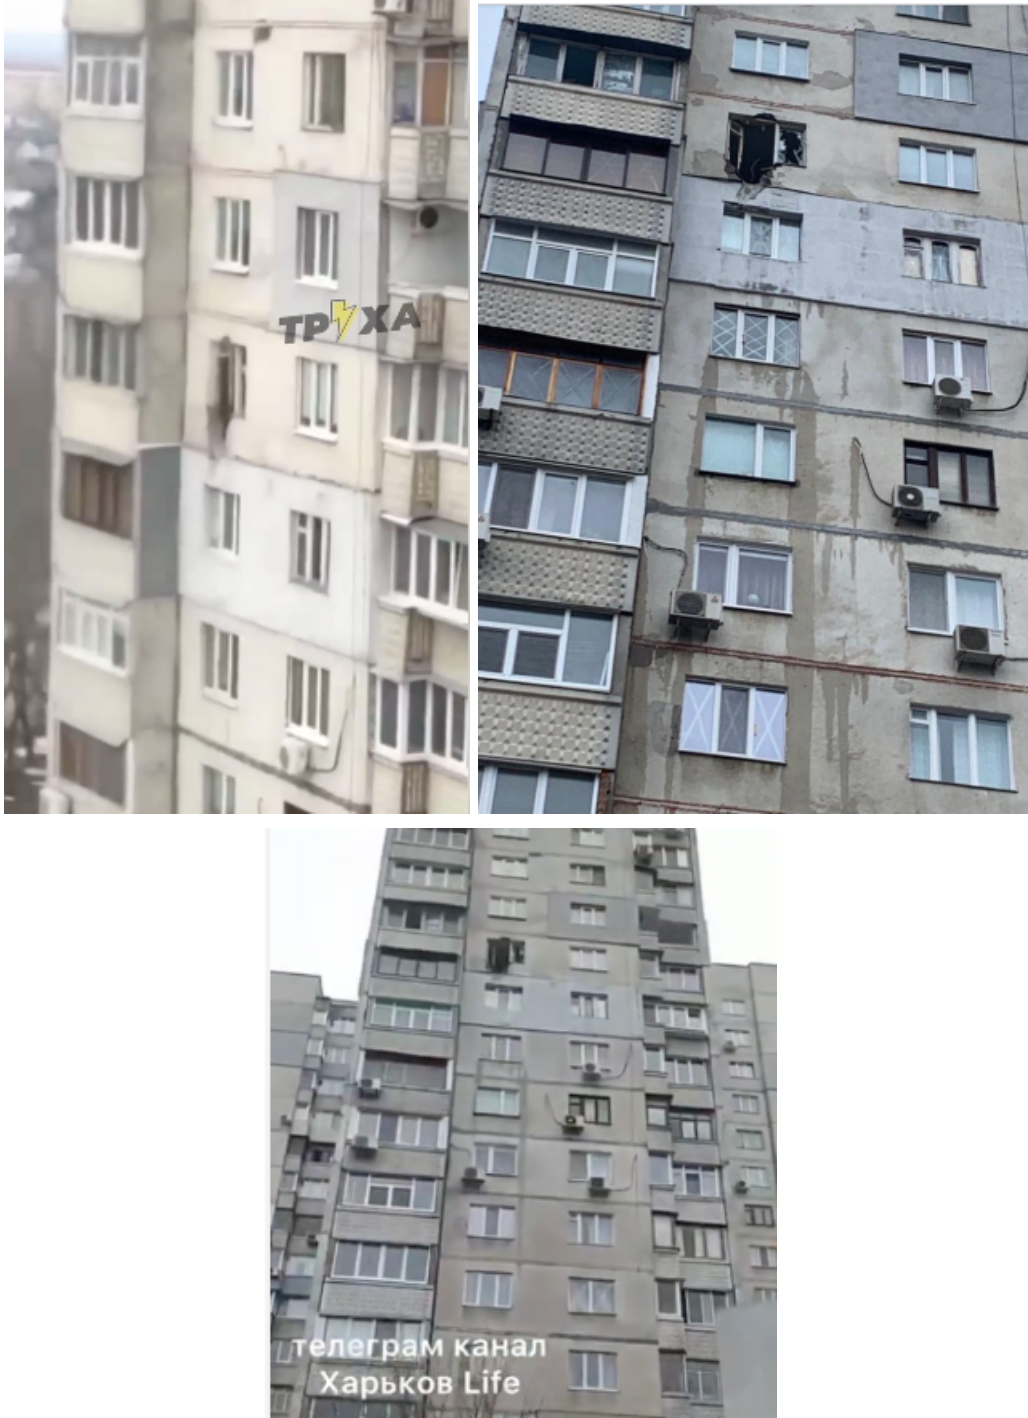
S2V1, S3I1, as well as S4V1 appear to depict the same large hole visible in a nearby apartment block - which appears to be very similar to the one visible in S1I1, but taken from outside.

Top left: A still from S2V1 depicting a hole in the neighboring building (cropped). Top right: S3I1 depicting what appears to be the same hole (cropped). Bottom: A still from S4V1 (cropped).

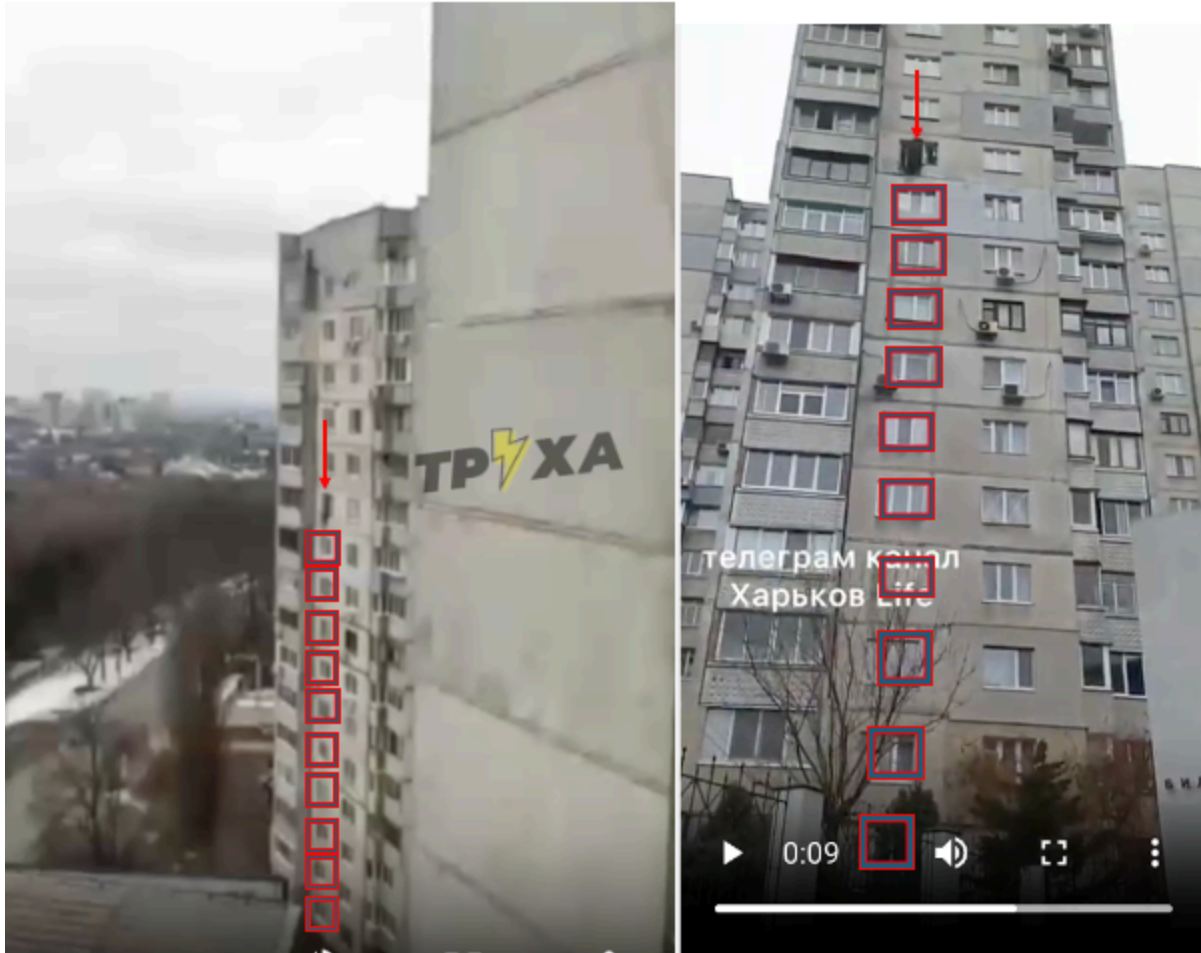
By analyzing S2V1 and S4V1, it was established that the hole is visible on the 11th floor, which is further supported by the conversation heard in the background of the S2V1.

Left: A still from S2V1 depicting the exterior of a building with a hole in it. Right: A still from S4V1 depicting the same incident and the exterior of a building with a hole in it. Note that the squares mark 10 separate floors of the highrise in each image, while the red arrows point to the hole in the exterior.

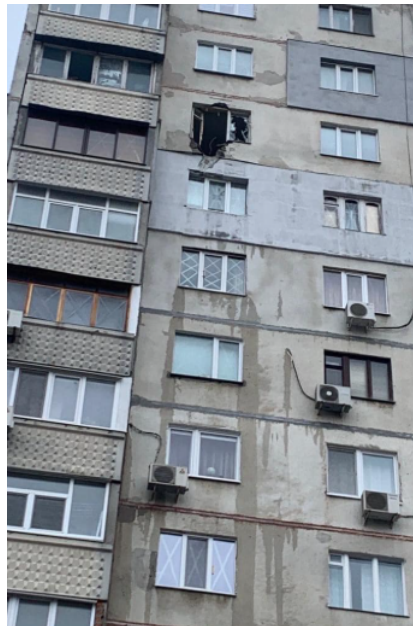
S3I1 (cropped).

S3I1 shows a closer-up external view of the building, which aligns with the features highlighted above – including coloration of the building, number and placement of air conditioning units, and location of the hole.

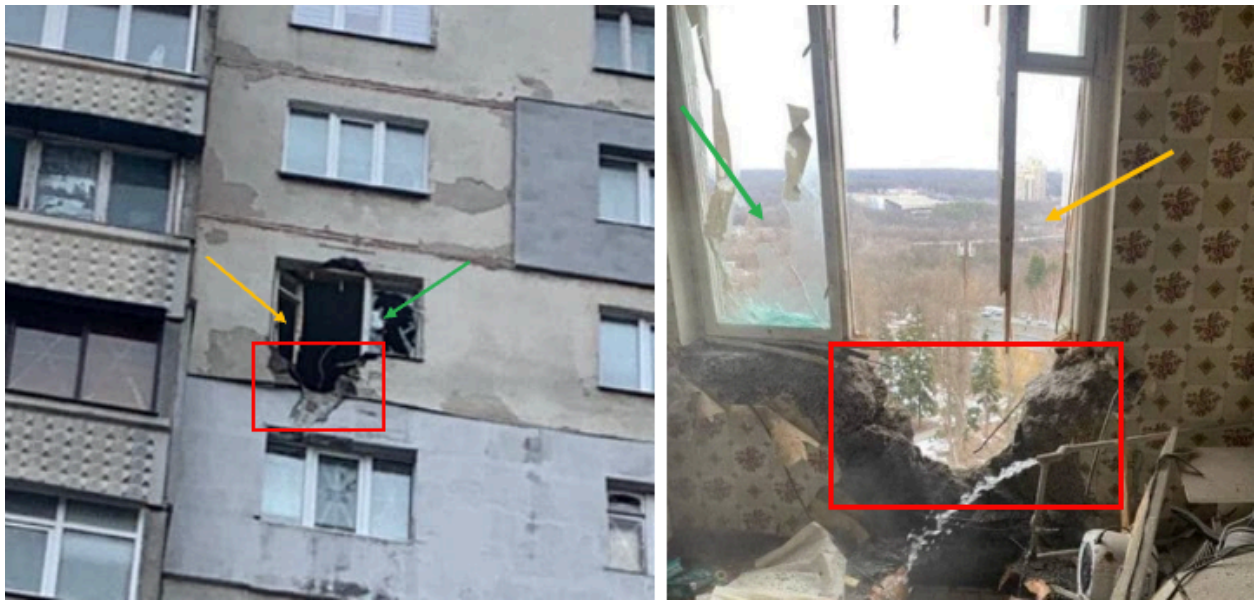
Left: A close up from S3I1 of the hole of impact from exterior. Right: A close up from S1I1 of the hole taken from inside. Note the matching damage to window panes (marked with arrows) and the wall under the window (marked with rectangle).

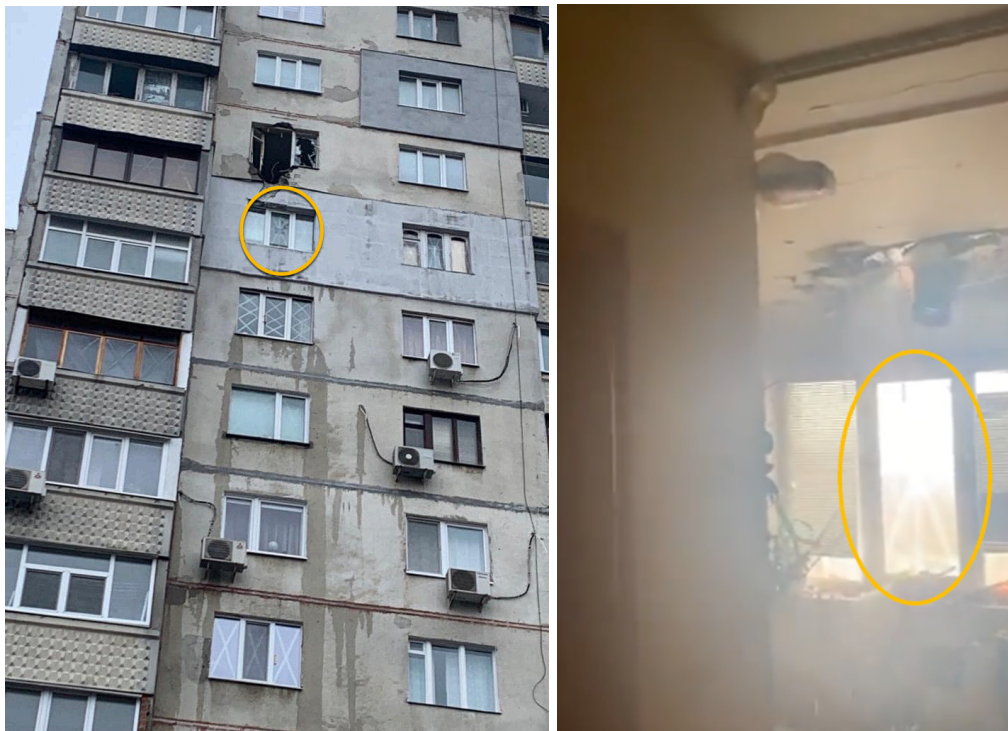
Notably, the same design of crosses in the window seen in S1V1 at 00:07 can be seen in the photo of the building in S3I1.

Left: S3I1, showing a cross-shaped pattern on the window pane. Right: a still from S1V1 taken at 00:07, showing the same cross-shaped pattern on the window pane.

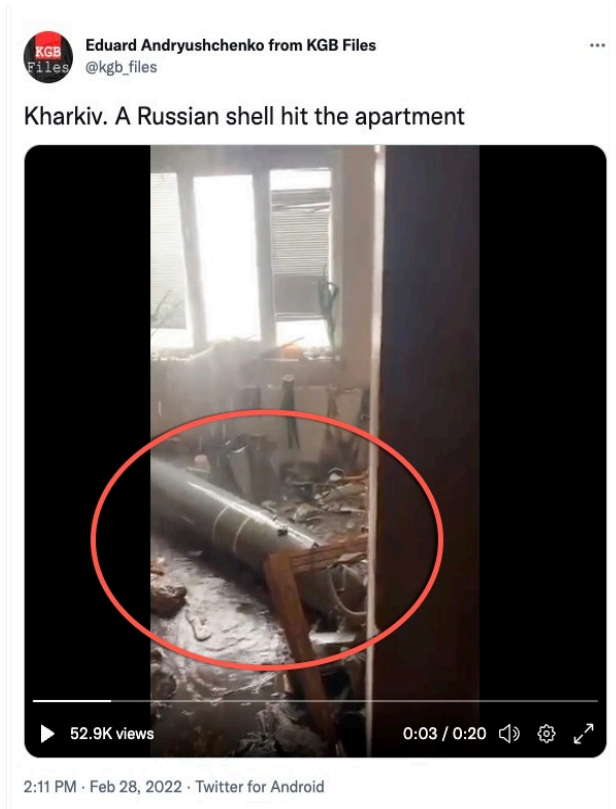
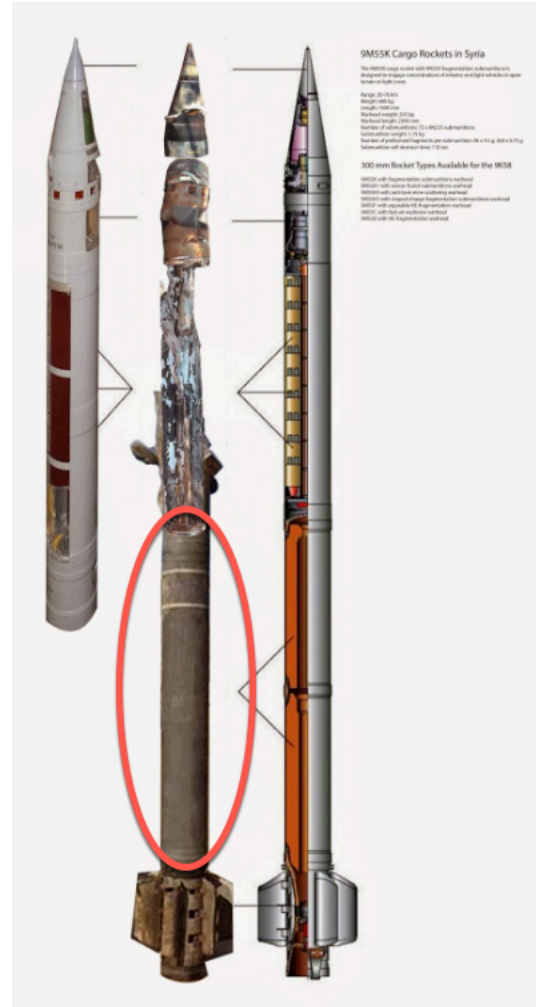
The rocket visible in [Source 1](#)¹⁹ appears to be a rocket motor of a 9M55K rocket based on its apparent size and markings. It was likely launched from a BM30 Smerch. Notably, there are no easily identifiable tails. However, when compared to reference photos (see below) of 9M55k rockets the markings appear to align. Additionally, the size appears to be much more consistent with a 300m rocket rather than a 220mm rocket as fired by a BM27.

Left: A still from S1V1 taken at 00:03. Right: [9M55K Reference photo](#)²⁰.

In the early hours of 28/02/2022, 50 Balakireva Street was hit on the 11th floor by a rocket motor. It was likely the rocket motor of a 9M55K rocket fired from a BM30 Smerch. This was determined based on the size and markings of the munition remnants. However, the tail section is not visible to make a conclusion with the highest certainty. The intended target is unknown, though an airport and an aircraft manufacturing company was within 1 km of the impact of the rocket motor. Although open sources demonstrate that Kharkiv was under bombardment at this time, it was not possible to identify where exactly the submunitions from this cluster munition impacted. The exact launch site of this munition was also not identified.

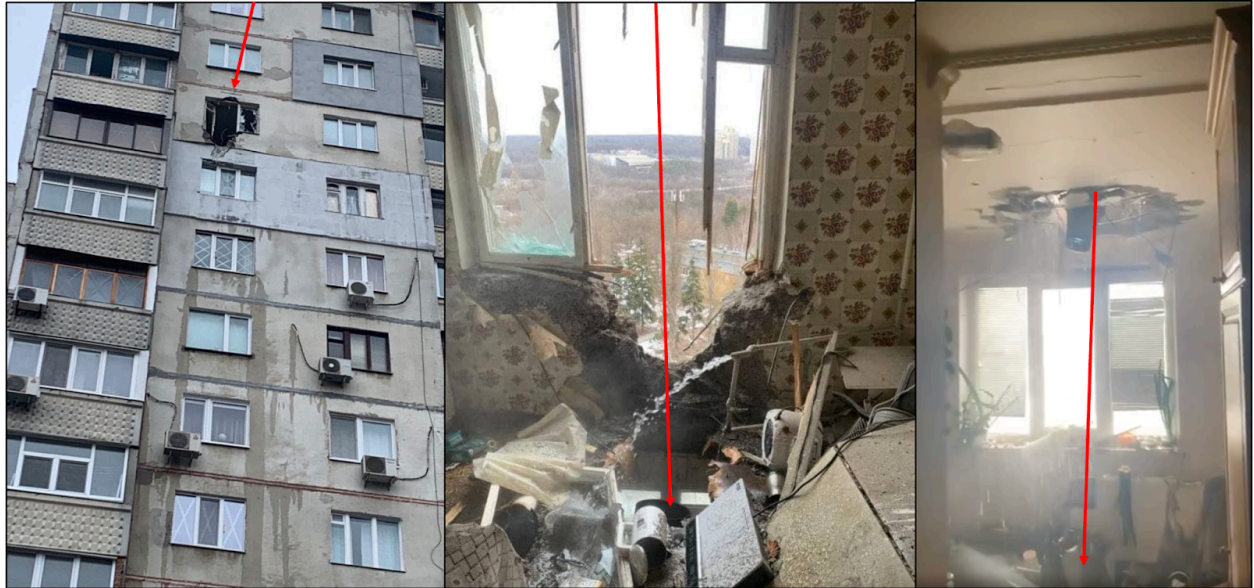
The BM30 “Smerch” system has a range of 20 to 70 km according to [Army Recognition](#)²¹. The circular hole as a result of the hit to 50 Balakireva Street’s facade appears to indicate that the rocket motor impacted it straight on from a relatively high angle, before continuing into the apartment below.

Damage indicates the progression of the rocket motor through the building. Left: S3I1, note the damage both to the top and bottom of the window frame. Middle: S1I1, note the hole visible in the floor immediately below the window. Right: A still from S1V1 (taken in the apartment immediately under the one where the two images were taken), Note the hole in the ceiling.

The damage visible allows for the plotting of a rough angle from in which the rocket motor may have landed. Plotting a 70km long line shows that the launch could have originated from territories east of Kharkiv. According to [LiveUAmap](https://liveuamap.com/),²² Russia was not reported to have had control over these territories at 28/02/2022. However their assessment of territories held at the time should be regarded as rough.

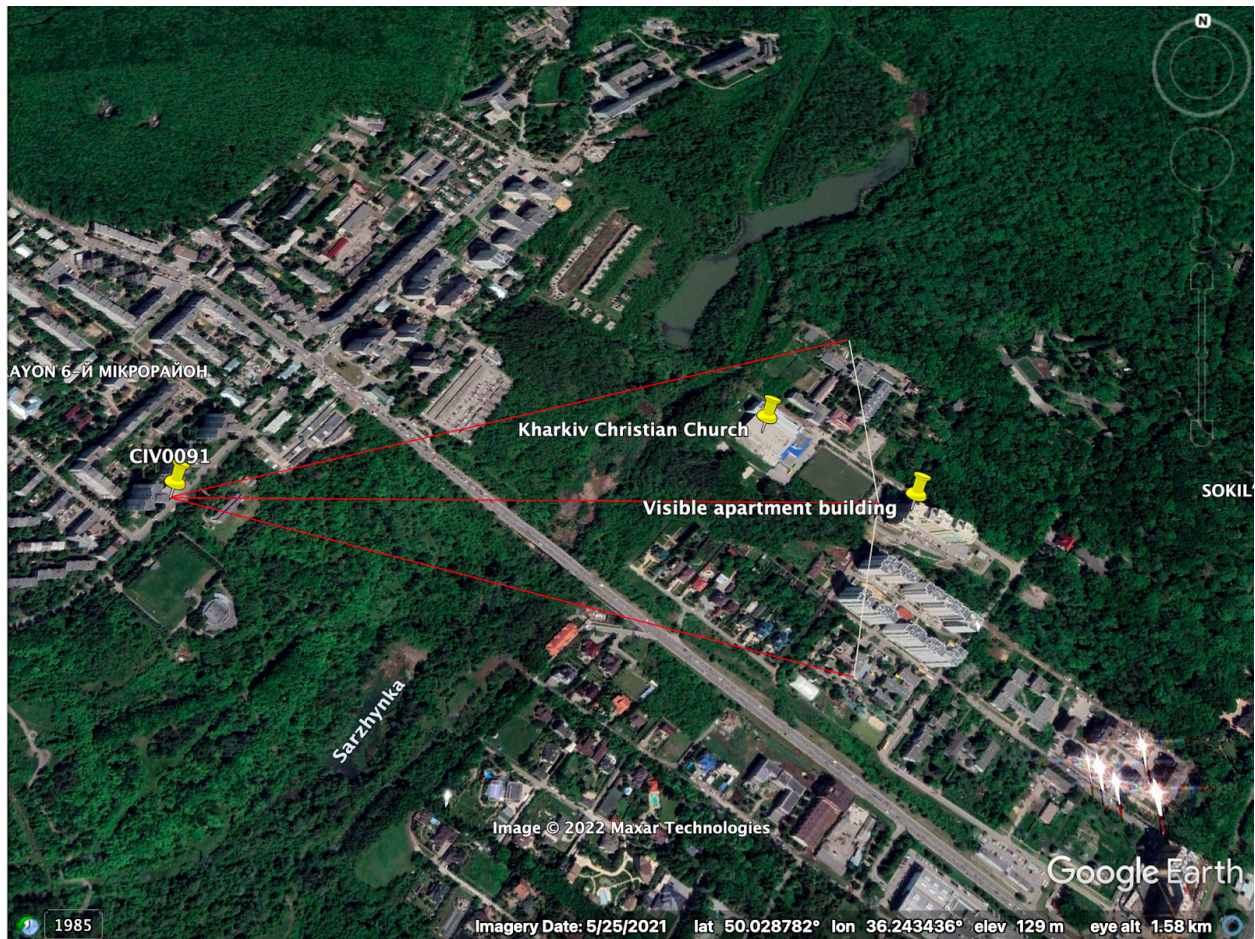
The building hit was a residential apartment building. At the time of the attack this location was under Ukrainian control, and there does not appear to have been any direct military use for it. Within 1 km from the impact with a 360m arc drawn, the area likely affected by the submunitions seems to be residential apartments, parts of Derevianka Street, the Kharkiv Christian Church, and a football field.

Satellite imagery from 25/05/2021 showing an arc with a 1 km radius from the impact zone (Credit: Google/Maxar Technologies).
